**Flood Control Project Maintenance
Levee Inspections**
LMA District Cover Sheet
Spring 2017 Levee Inspection Results

Reclamation District No. 2103 Wheatland Vicinity

Spring 2017 Levee Inspection Results

Waterway			Bank	Unit Miles
Unit No. 01 South Dry Creek			Left	4.64
	Spring (March - May)	Summer (June - August)	(September - November) Fall	Winter (December - February)
Unit Maintenance Rating (Fall Only)				
Date of Inspection	4/27/2017 - 4/27/2017			
DWR Inspector	Sterling York			
Accompanied By	Tom Engler RD 2103

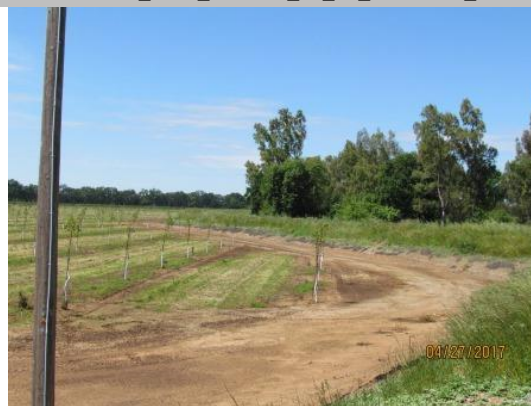
Photo 1 of 1 : SP_2017_RD2103_10_24_20170428_00044.jpg

LM Start	0.00	Rating **	M	Issue No.	28
LM End	0.00	Issue Type +	En	Location *	N/A
Category	Supplemental			GPS Latitude/Longitude	
				Start	End
Item	DWR UCIP Field Study			38.998295 °	38.998295 °
				-121.415186 °	-121.415186 °
DWR ID					
Comment Code					
Inspector Comment					
FS_ID:39966					
DS_ID:24881					
EP_NO: N/A					
Repair Type: Non-Urgent					
Crossing Status: Indicator Found					
UCIP Comments:					
FIELD_STRUCT_DESC: Gas line through levee. Markers visible on both sides.					
FS Date: 3/4/2014

View looking downstream of annual vegetation that needs to be maintained, Spring 2017.

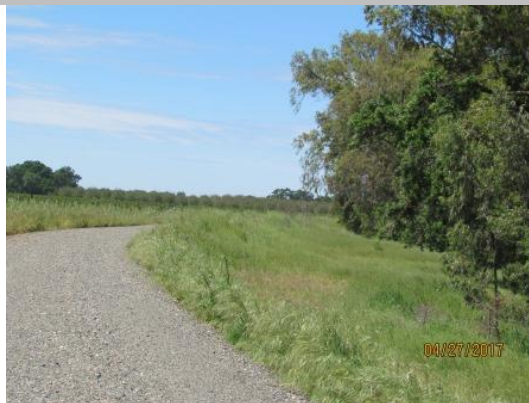
Photo 1 of 1 : SP_2017_RD2103_10_25_20170428_00043.jpg

View looking downstream of annual vegetation that needs to be maintained, Spring 2017.

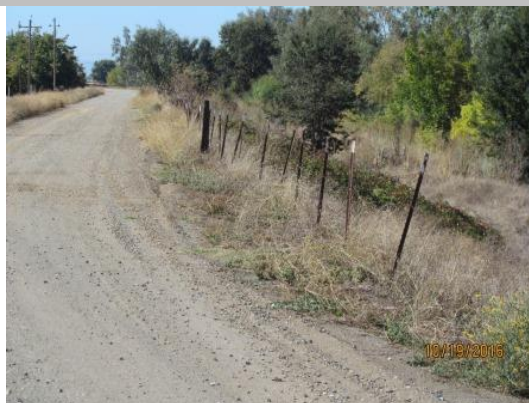
Photo 1 of 1 : SP_2017_RD2103_10_11_20170316_00003.jpg

LM Start	0.01	Rating **	M	Issue No.	11	
LM End	0.47	Issue Type +	En	Location *	WS	
Category	Earthen Levee			GPS Latitude/Longitude		
				Start		End
Item	Encroachments			39.019849 °		39.021775 °
				-121.453871 °		-121.445642 °
DWR ID	DWR_RD2103_01_f_2013_11					
Comment Code						
FE : Fence						
Inspector Comment						
Fence along waterside hinge point.

View of fence along waterside hinge point looking downstream.

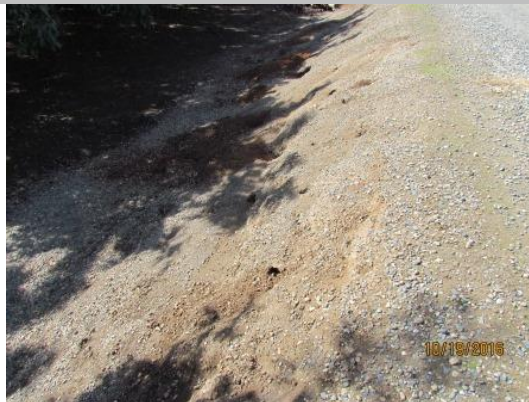
Photo 1 of 1 : SP_2017_RD2103_10_23_20170316_00007.jpg

LM Start	0.20	Rating **	M	Issue No.	23
LM End	0.22	Issue Type +	Ma	Location *	LS
Category	Earthen Levee			GPS Latitude/Longitude	
				Start	End
Item	Animal Control			39.020856 °	39.020938 °
				-121.450629 °	-121.450237 °
DWR ID	DWR_RD2103_01_f_2015_23				
Comment Code					
A3 : No rodents visible, but rodent burrows visible; need to backfill and compact or grout burrows.					
Inspector Comment					
No animal activity observed, Spring 2017.

View of squirrel holes on the waterside looking downstream. Fall 2016.

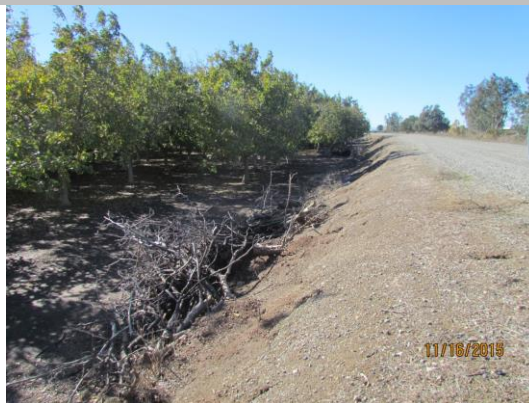
Photo 1 of 2 : SP_2017_RD2103_10_22_20170316_00005.jpg

Pruning's still exist as of Spring 2017.

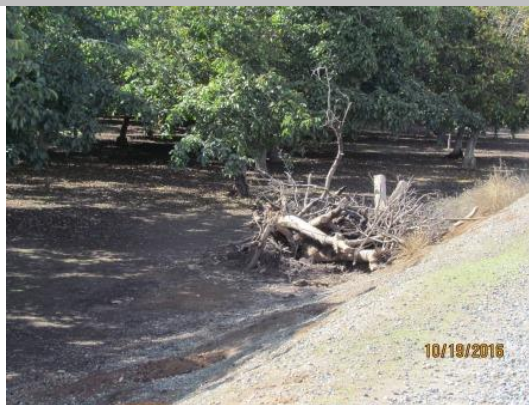
Photo 2 of 2 : SP_2017_RD2103_10_22_20170316_00006.jpg

Pruning's still exist as of Fall 2016.

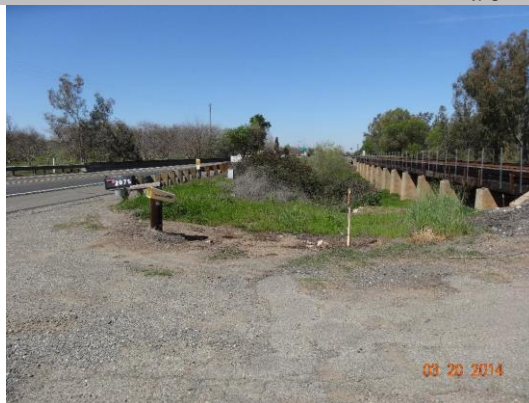
Photo 1 of 3 : UCIP_SP_2017_39985_69852.jpg

FS_ID:39985
DS_ID:19468
EP_NO: 3659
Repair Type: Non-Urgent
Crossing Status: Indicator Found
UCIP Comments: Need to contact owner to determine status of crossing. Need date of last inspection and confirmation that crossing is still in operable condition. It appears this is the same line as the next entry however, permit calls for Southern Pacific Pipe Lines, Inc as the owner and the sign found in the field indicates Kinder Morgan as owner. Need to contact owner to clarify if 2 crossings exist or if crossing is same owner will need to update permit information.
FIELD_STRUCT_DESC: 8-5/8-inch steel fuel line through the levee, 3.0 feet below the crown. Cutoff wall around pipe at centerline of levee. Pipe extends through overflow area. (Permit No. 3569-1961). This entry matches the Drainage or Irrigation Structure referenced in O&M manual (HLM 0.55). Markers visible on both sides.
FS Date: 3/20/2014

Marker visible on toe in between railroad tracks and highway (north).

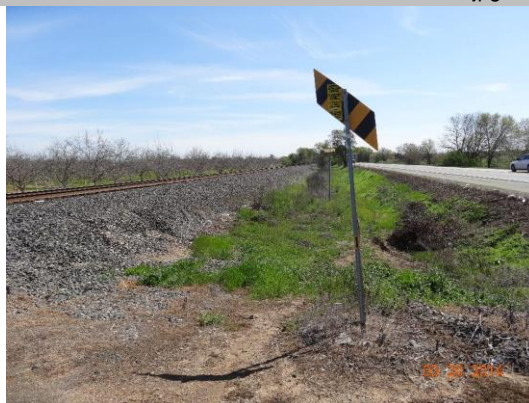
Photo 2 of 3 : UCIP_SP_2017_39985_69851.jpg

Marker visible on toe in between railroad tracks and highway (south).

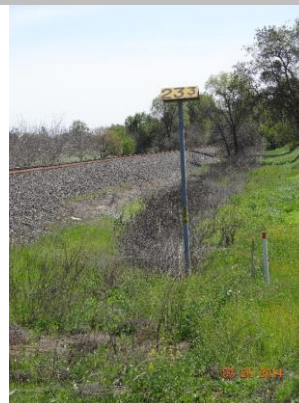
Photo 3 of 3 : UCIP_SP_2017_39985_69853.jpg

Comment Code						
Inspector Comment						
FS_ID:39985 DS_ID:19468 EP_NO: 3659 Repair Type: Non-Urgent Crossing Status: Indicator Found UCIP Comments: Need to contact owner to determine status of crossing. Need date of last inspection and confirmation that crossing is still in operable condition. It appears this is the same line as the next entry however, permit calls for Southern Pacific Pipe Lines, Inc as the owner and the sign found in the field indicates Kinder Morgan as owner. Need to contact owner to clarify if 2 crossings exist or if crossing is same owner will need to update permit information. FIELD_STRUCT_DESC: 8-5/8-inch steel fuel line through the levee, 3.0 feet below the crown. Cutoff wall around pipe at centerline of levee. Pipe extends through overflow area. (Permit No. 3569-1961). This entry matches the Drainage or Irrigation Structure referenced in O&M manual (HLM 0.55). Markers visible on both sides. FS Date: 3/20/2014

Marker visible on toe in between railroad tracks and highway (south).

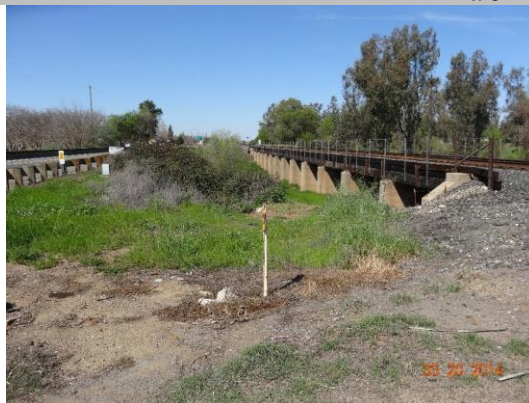
Photo 1 of 3 : UCIP_SP_2017_39986_71882.jpg

Comment Code					
Inspector Comment					
FS_ID:39986 DS_ID:24878 EP_NO: N/A Repair Type: Non-Urgent Crossing Status: Indicator Found UCIP Comments: It appears this is the same line as the next entry however, permit calls for Southern Pacific Pipe Lines, Inc as the owner and the sign found in the field indicates Kinder Morgan as owner. Need to contact owner to clarify if 2 crossings exist or if crossing is same owner will need to update permit information. Also need to contact owner to determine status of crossing. Need date of last inspection and confirmation that crossing is still in operable condition. FIELD_STRUCT_DESC: Kinder Morgan line through levee. Markers visible on both banks. FS Date: 3/4/2014

View of marker visible on waterward side (between HWY 65 and railroad).

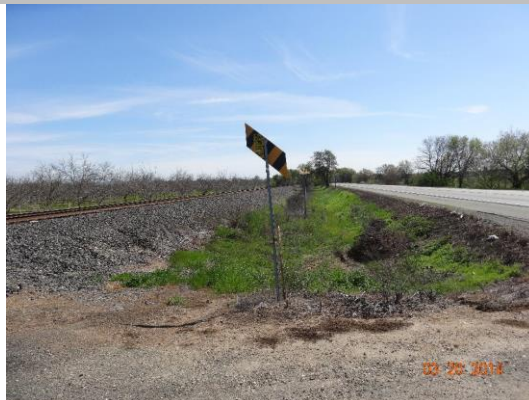
Photo 2 of 3 : UCIP_SP_2017_39986_71881.jpg

Markers visible on landward side.

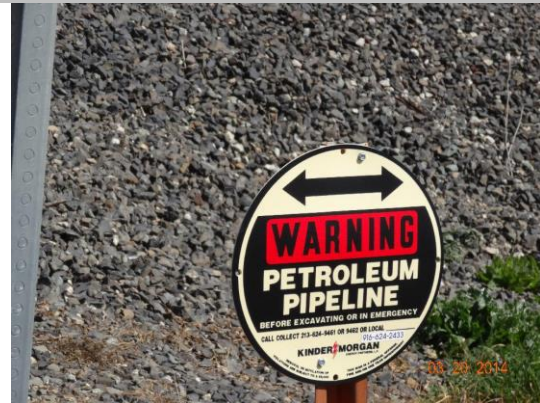
Photo 3 of 3 : UCIP_SP_2017_39986_71880.jpg

Comment Code						
Inspector Comment						
FS_ID:39986						
DS_ID:24878						
EP_NO: N/A						
Repair Type: Non-Urgent						
Crossing Status: Indicator Found						
UCIP Comments: It appears this is the same line as the next entry however, permit calls for Southern Pacific Pipe Lines, Inc as the owner and the sign found in the field indicates Kinder Morgan as owner. Need to contact owner to clarify if 2 crossings exist or if crossing is same owner will need to update permit information. Also need to contact owner to determine status of crossing. Need date of last inspection and confirmation that crossing is still in operable condition.						
FIELD_STRUCT_DESC: Kinder Morgan line through levee. Markers visible on both banks.						
FS Date: 3/4/2014

Petroleum Pipeline owned by Kinder Morgan.

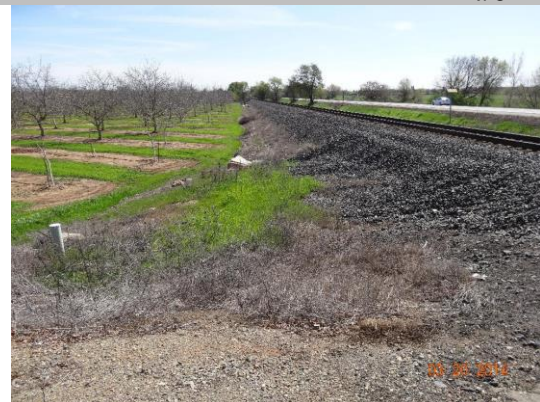
Photo 1 of 1 : UCIP_SP_2017_43823_73340.jpg

LM Start	0.55	Rating **	M	Issue No.	31
LM End	0.55	Issue Type +	En	Location *	LS
Category	Supplemental			GPS Latitude/Longitude	
				Start	End
Item	DWR UCIP Field Study			39.022654 °	39.022654 °
				-121.444665 °	-121.444665 °
DWR ID					
Comment Code					
Inspector Comment					
FS_ID:43823 DS_ID:19467 EP_NO: 16041 Repair Type: Non-Urgent Crossing Status: Indicator Found UCIP Comments: Needs markers at levee crossing. FIELD_STRUCT_DESC: 2-inch steel communication conduit encasing telephone cable through the levee, 2-feet below the crown. Extends to junction box 10-feet from landward toe, parallel to railroad tracks. (Permit No. 16041-1993). FS Date: 3/18/2015

Junction box visible on LS toe (at lower left of photo).

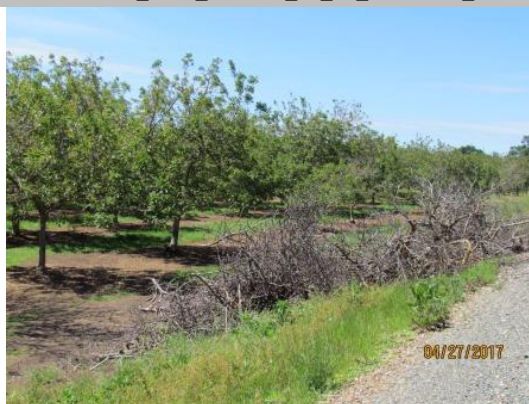
Photo 1 of 1 : SP_2017_RD2103_10_27_20170428_00047.jpg

View looking downstream of pruning's on the levee slope, Spring 2017.

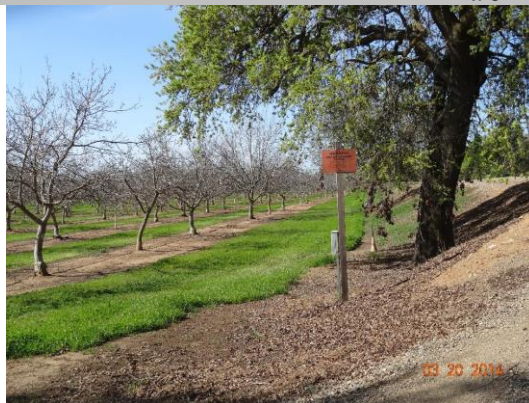
Photo 1 of 3 : UCIP_SP_2017_39988_71890.jpg

LM Start	0.81	Rating **	M	Issue No.	35
LM End	0.81	Issue Type +	En	Location *	LS
Category	Supplemental			GPS Latitude/Longitude	
				Start	End
Item	DWR UCIP Field Study			39.024725 °	39.024725 °
				-121.440978 °	-121.440978 °
DWR ID					
Comment Code					
Inspector Comment					
FS_ID:39988					
DS_ID:24880					
EP_NO: N/A					
Repair Type: Non-Urgent					
Crossing Status: Indicator Found					
UCIP Comments: No marker found on waterward side--need to confirm with owner if crossing goes through levee. If so, need depth of crossing through levee. Also need to obtain permit number used to authorize crossing.					
FIELD_STRUCT_DESC: Conduit line through levee. Marker visible on landward side.					
FS Date: 3/4/2014

Underground cable line marker visible on landward side toe.

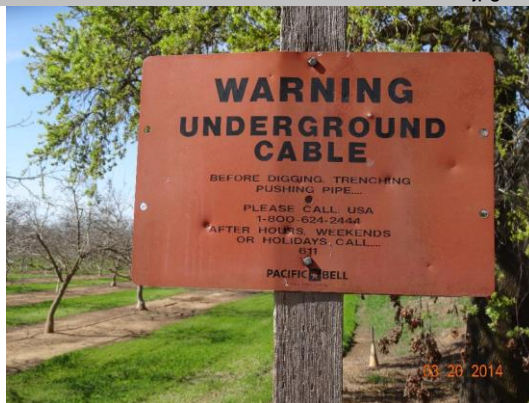
Photo 2 of 3 : UCIP_SP_2017_39988_71889.jpg

Marker is for underground cable line owned by Pacific Bell.

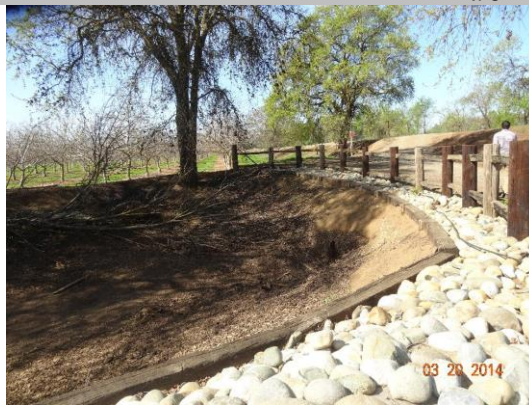
Photo 1 of 3 : UCIP_SP_2017_38325_69869.jpg

LM Start	0.82	Rating **	A/W	Issue No.	36
LM End	0.82	Issue Type +	Ma	Location *	LS
Category	Supplemental			GPS Latitude/Longitude	
				Start	End
Item	DWR UCIP LMA Responsibility			39.024811 °	39.024811 °
				-121.440750 °	-121.440750 °
DWR ID					
Comment Code					
Inspector Comment					
FS_ID:38325					
DS_ID:19471					
EP_NO: N/A					
Repair Type: No Action Needed					
Crossing Status: Found					
UCIP Comments:					
FIELD_STRUCT_DESC: 36-inch CM drainpipe through the levee, 14.4 feet below the crown. Concrete headwall, flap-gate and 3x6-foot concrete splash apron at waterward toe. Outfall drain from old Grasshopper Slough. (USACE-1962). This entry matches the Drainage or Irrigation Structure referenced in O&M manual (HLM 0.83).					
FS Date: 3/20/2014

View of CMP crossing located on landward side.

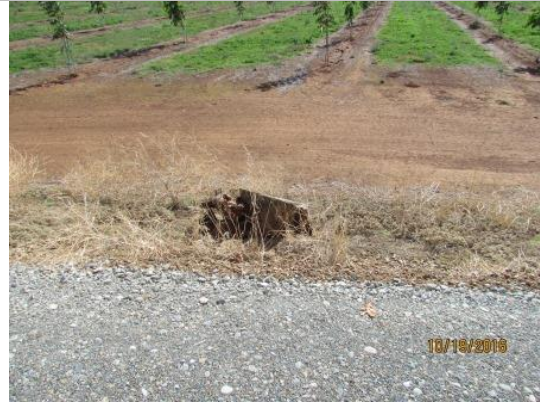
Photo 1 of 1 : SP_2017_RD2103_10_26_20170316_00008.jpg

View of tree stump on lanside levee slope. Fall 2016.

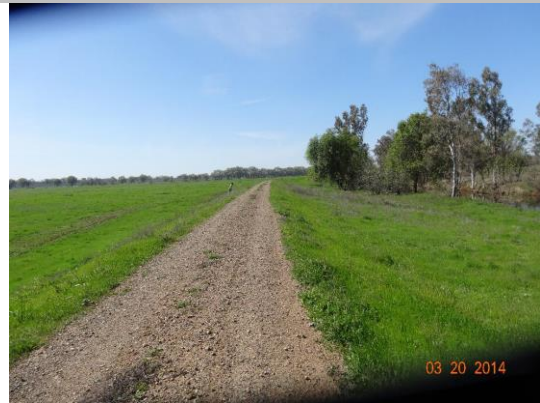
Photo 1 of 3 : UCIP_SP_2017_41183_69917.jpg

Comment Code					
Inspector Comment					
FS_ID:41183 DS_ID:19473 EP_NO: 1886 Repair Type: Non-Urgent Crossing Status: Indicator Found UCIP Comments: Need to coordinate with owner. Severely corroded section of steel pipe present on waterward side--no other evidense present at this location. Owner will need to coordinate with CVFPB and DWR-Inspector to determine proper action to abandon crossing. FIELD_STRUCT_DESC: *ABANDONED* 12-inch steel irrigation pipe through the levee, 3.1 feet below the crown. Siphon breaker on the waterward slope. Concrete standpipe at the landward toe. Vertical pump on waterward side. Open on waterward end. Permit includes gravel dam through channel of Dry Creek. (Permit No. 1886-1959). This entry matches the Drainage or Irrigation Structure referenced in O&M manual (HLM 1.86). Crossing is angled 45 degrees. FS Date: 3/20/2014

Overview of levee crown.

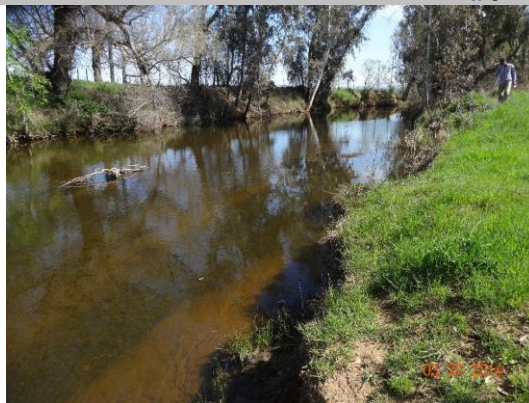
Photo 3 of 3 : UCIP_SP_2017_38327_69879.jpg

LM Start	1.86	Rating **	M	Issue No.	38 (cont)	
LM End	1.86	Issue Type +	En	Location *	LS	
Category	Supplemental			GPS Latitude/Longitude		
				Start	End	
Item	DWR UCIP Field Study			39.029694 °	39.029694 °	
				-121.423946 °	-121.423946 °	
DWR ID						
Comment Code						
Inspector Comment						
FS_ID:38327						
DS_ID:19512						
EP_NO: N/A						
Repair Type: Non-Urgent						
Crossing Status: Indicator Found						
UCIP Comments: Unable to determine if there is a crossing through pipe. Will need to coordinate with owner to determine additional information about appurtenances found on landward side.						
FIELD_STRUCT_DESC: Irrigation pump, service pole, and 36-inch concrete standpipe, 5 feet from the landward toe. No pump was found during field visit 3/20/14.						
FS Date: 3/20/2014

No crossing visible on waterward side.

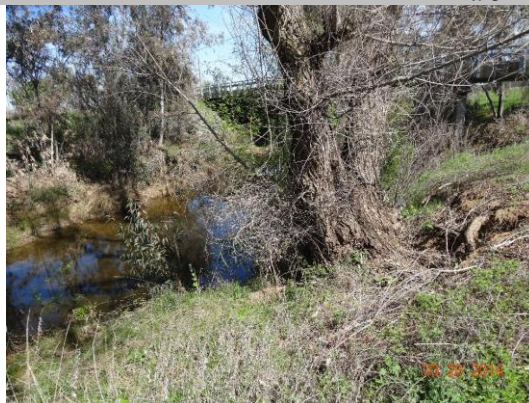
Photo 2 of 3 : UCIP_SP_2017_38331_69893.jpg

Crossing was not visible on waterward side.

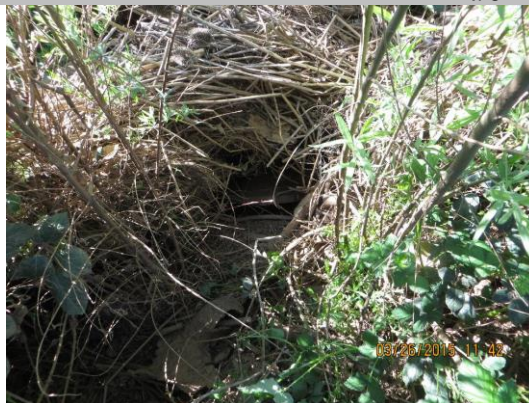
Photo 1 of 3 : UCIP_SP_2017_50033_73429.jpg

Flapgate at WS berm blocked by soil and vegetation buildup.

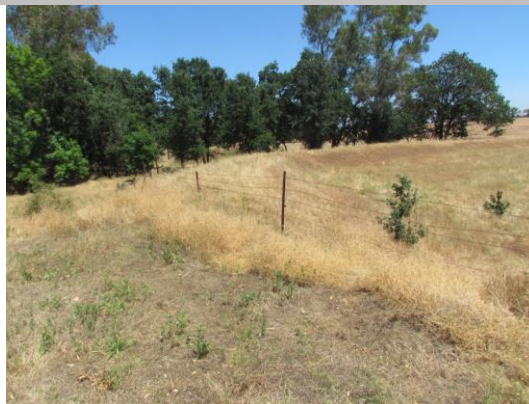
Photo 1 of 1 : SP_2017_RD2103_10_20_20170316_00004.jpg

View of the fence blocking access to the crown of the levee. View is from the crown facing upstream.

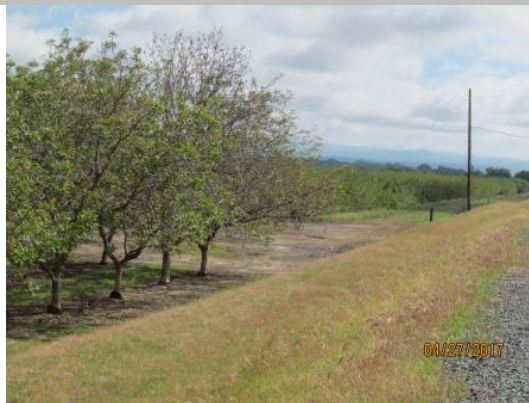
Photo 1 of 1 : SP_2017_RD2103_11_14_20170428_00031.jpg

View looking upstream of the annual vegetation that needs to be maintained, Spring 2017.

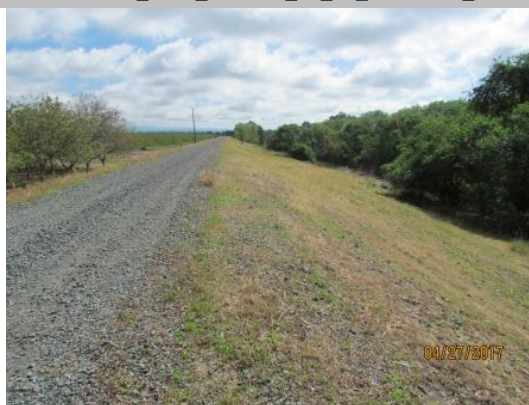
Photo 1 of 1 : SP_2017_RD2103_11_15_20170428_00032.jpg

View looking upstream of the annual vegetation that needs to be maintained, Spring 2017.

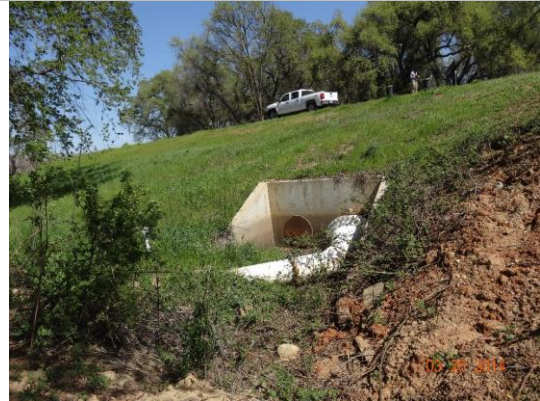
Photo 3 of 3 : UCIP_SP_2017_40046_71919.jpg

Concrete headwall visible on waterward side--white pipe attached to crossing at headwall.
